# Erosion at the Fairfield Osborn Preserve

Jose Ochoa, Lauren Cleveland, Emily Vargas, and Luis Luna

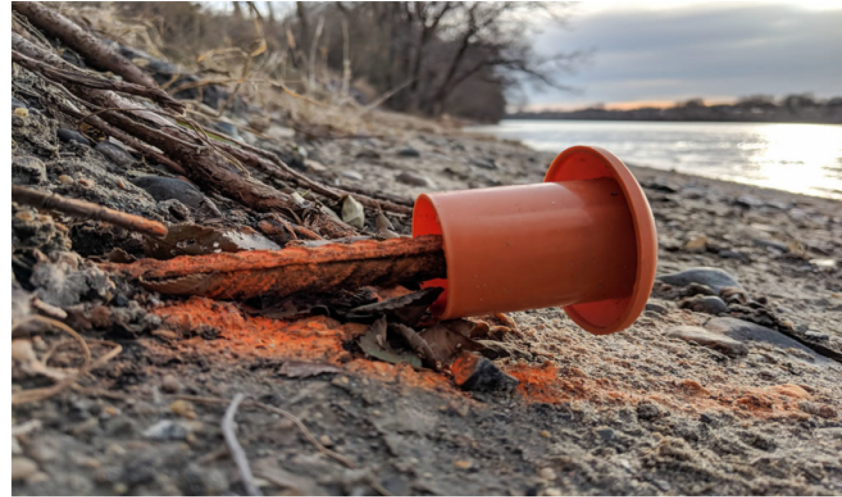
Erosion Pin

- We measured the change in amount of erosion in areas close to the creek; using erosion pins put in by Michelle Goman
- We measured at the same spots as the previous study:
  - 9 out 15 pins in total (lower/upper cross section-North)
- Noticed differences in plant life near erosion pins (low to high)

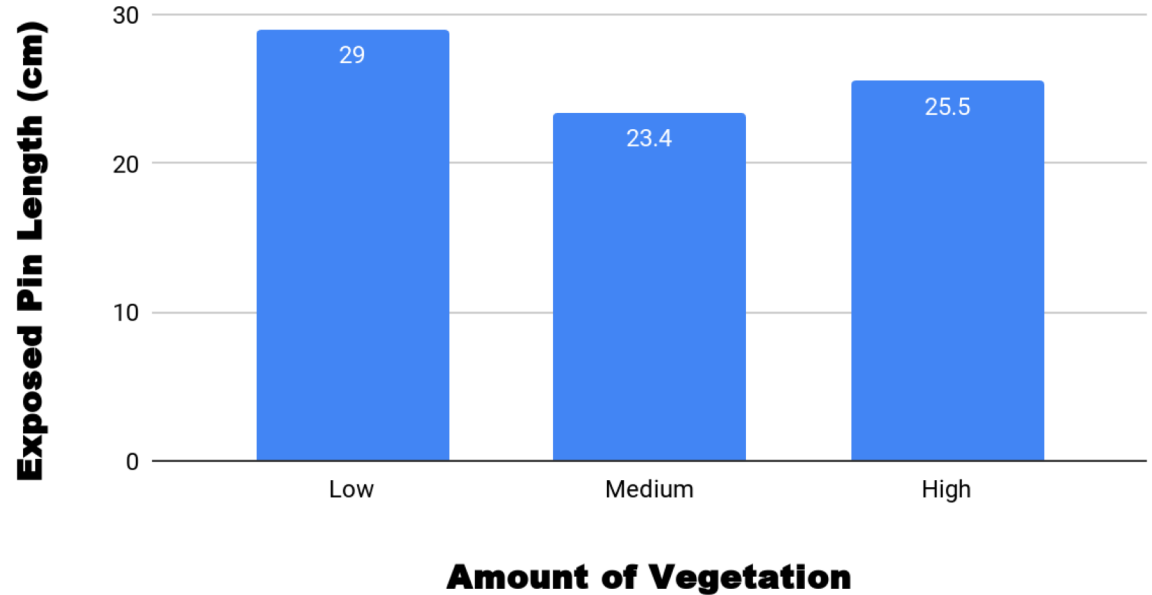
**Amount of Erosion vs. Amount of Vegetation**

- Can't conclude for 100% certainty that there is more erosion on the Upper than the Lower because of sample sizes (pin #, year)
- Unable to answer hypothesis 1
- Also unable to decipher which pins are which, can't compare the previous data collected
- Pins with trees/vegetation close by had slightly less erosion
- Both areas had a good amount of vegetation, but the Upper Section had less

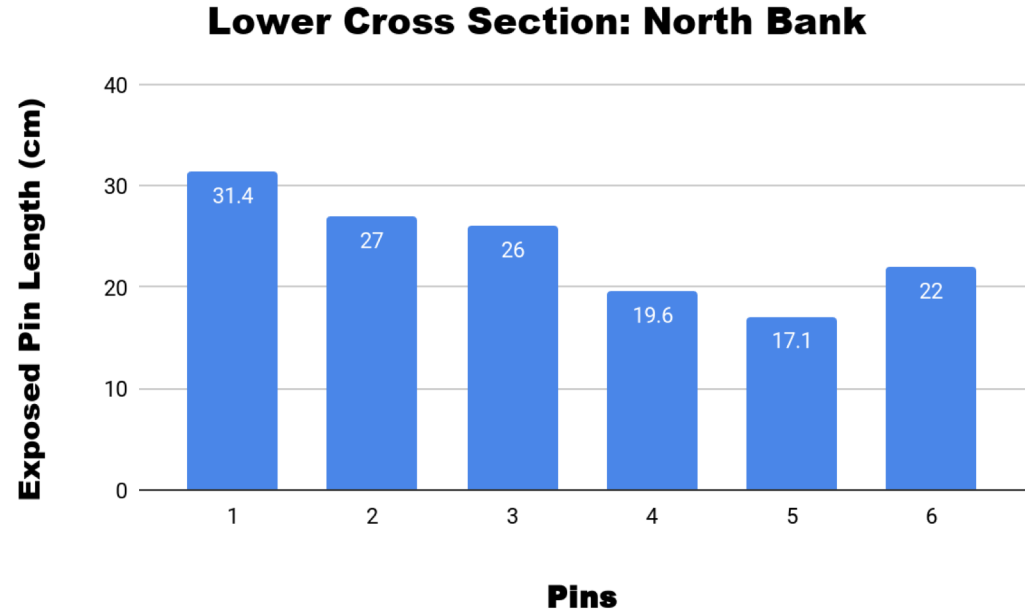
# Lower Cross Section: North Bank Data

Lower Cross Section: North Bank	
Pin	Measurement (cm)
1	31.4

2	27

3	26

4	19.6

5	17.1

6	22

- Graph of the Upper Cross Section: North Bank shows noticeable erosion
  - average amount of erosion is about 25.9cm
- Graph of the Lower Cross Section: North Bank had quite a bit of noticeable erosion
  - average amount of erosion is about 23.9cm
- From the averages of all the data, we see there is more erosion in the Upper than the Lower
