Introduction and Background

We surveyed Copeland Creek channel morphology and pebble size distribution along three perpendicular transect lines located within the portion of Copeland Creek running through Sonoma State University.

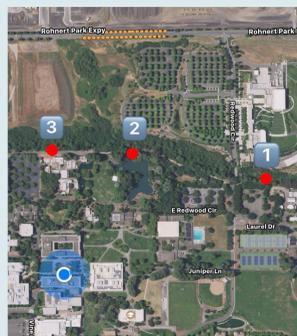
Figure 2: Testing sites; 1 is Butterfly Garden, 2 is Ponds, and 3 is Art Building.

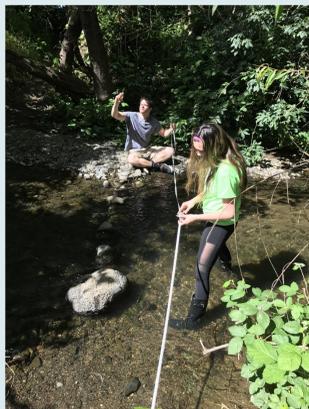
Figure 3: Cerena Clifford and Grant Morley seeking measurements at site 3

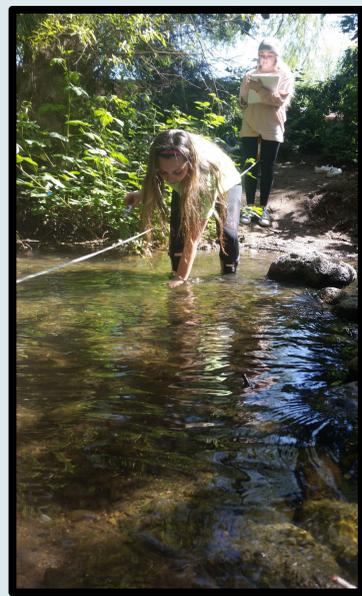
Figure 4: Cerena Clifford measuring rocks while Serena Vesia records the data.

We took measurements of length, width, and depth of pebble along the transect lines.
